MISCELLANEOUS PAPER HL-83-3

WAVE AND SEEPAGE-FLOW EFFECTS ON SAND STREAMBANKS AND THEIR PROTECTIVE COVER LAYERS

Demonstration Hydraulic Models

Final Report

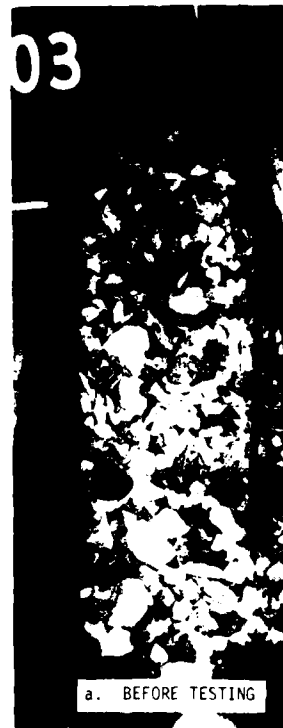
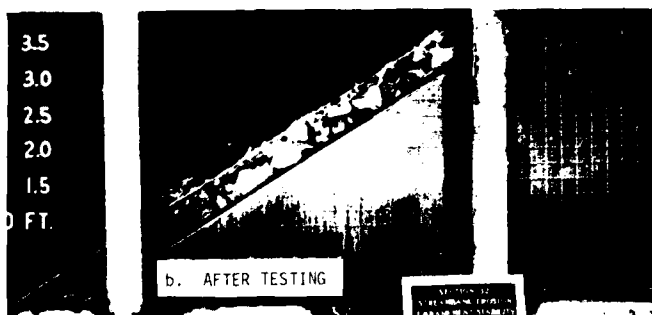
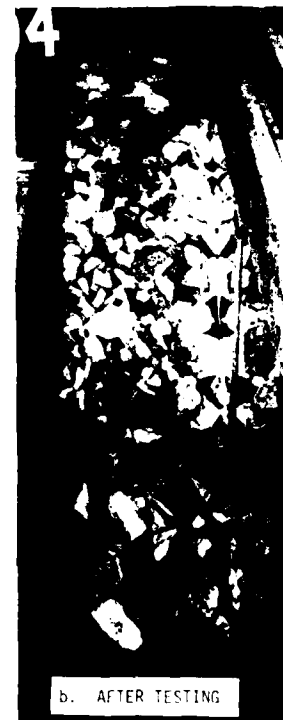
Figure 74. Plan 5A, before and after testing 2.0-sec, 0.70-ft nonbreaking waves

45. Plans 3, 5A, and 6 were exposed to 2.0- and 4.0-sec, 0.70-ft nonbreaking waves. All three plans accrued minor to moderate damage to the riprap protection; but in all cases, displacement of the protective riprap layer stabilized well before the end of the tests. At no time were any of the filters exposed to direct wave attack due to holes

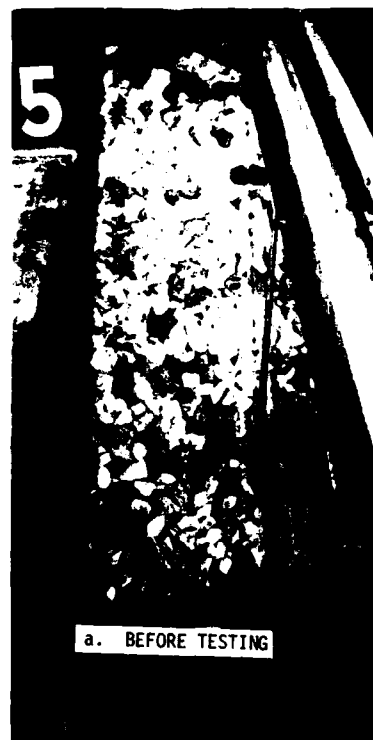
Figure 77. Plan 6, before and after testing 4.0-sec
0.70-ft nonbreaking waves

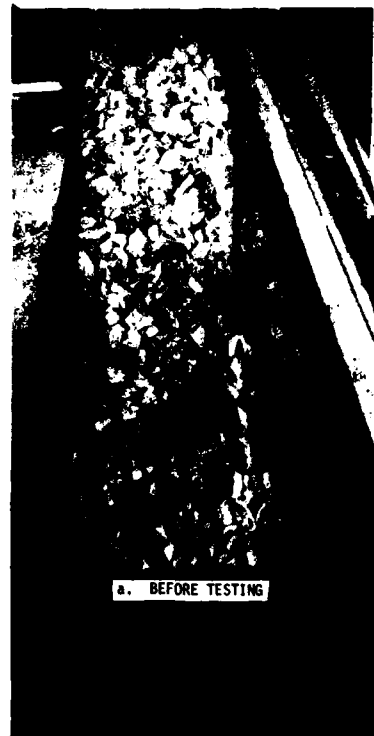
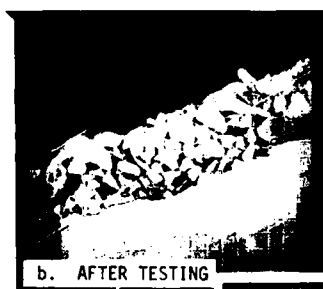
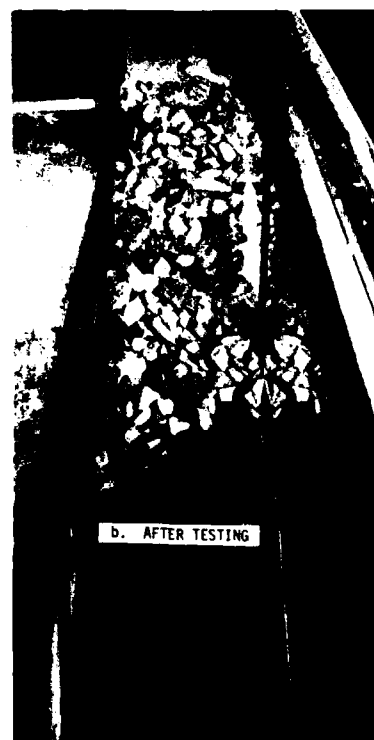
Figure 80. Plan 4A, before and after testing 2.0-sec, 0.75-ft nonbreaking waves

46. Plans 1, 3, 4A, and 6 were exposed to 2.0-sec, 0.75-ft non-breaking waves. Plans 1 and 4A failed and would have continued to deteriorate had the tests been continued. Plans 3 and 6 showed similar results to that which occurred when they were exposed to the 2.0- and 4.0-sec, 0.70-ft nonbreaking waves. Some increased riprap displacement was noted with this higher wave height, but all damage had stopped before the end of each test and in no instance did either of Plans 3 or 6 fail to protect the sand streambank. Some downslope movement of sand occurred beneath the filter fabric in Plan 6. This movement was the same, both in type and amount, as had occurred in Plans 5A and 6 when

exposed to the 0.70-ft nonbreaking waves discussed in paragraph 45. Figures 78-81 show the condition of Plans 1, 3, 4A, and 6 both before and after exposure to the 2.0-sec, 0.75-ft nonbreaking waves.
